# White Paper

## Are you using tubing and fittings that will fail the required ASME BPE Testing?

by Carl Kettermann, Metallurgist  
United Industries, Inc.

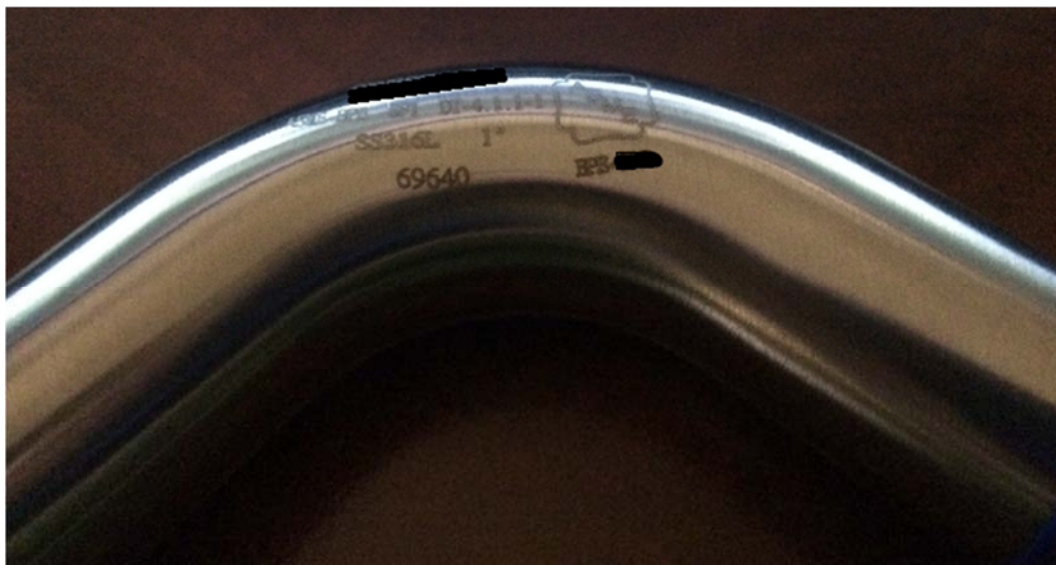
Fig. 1. Sample of a 1.00" 90 degree elbow as received. Note that it is certified as being BPE compliant as indicated by the ASME symbol stamp. Information identifying the manufacturer is blacked out.

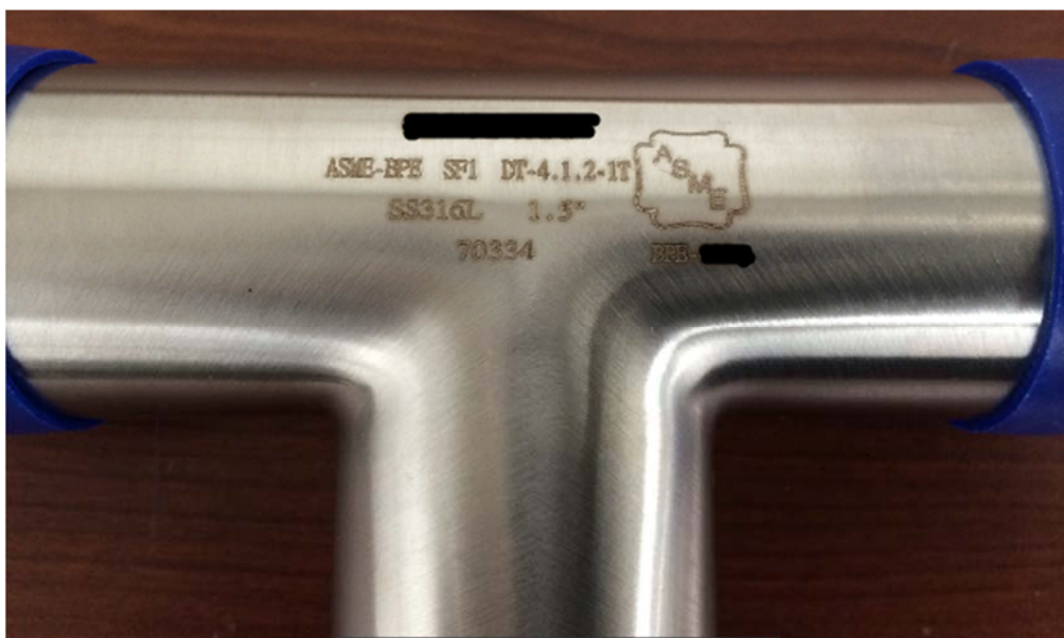
Fig 2. Sample of a 1.50" Tee as received. Note that it is certified as being BPE compliant as indicated by the ASME symbol stamp. Information identifying the manufacturer is blacked out.

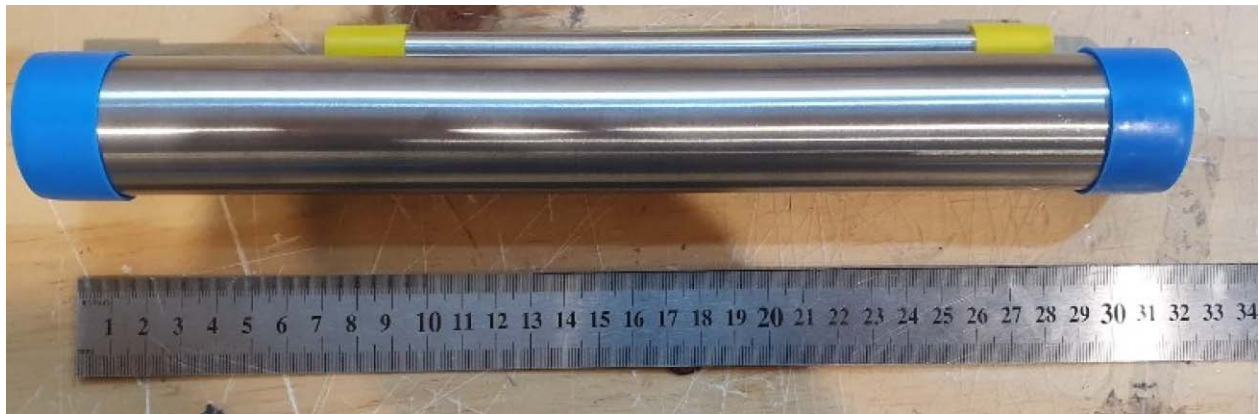
Fig. 3. Samples of 0.50" and 1.50" OD straight length tubing as delivered from the same supplier as the above fittings.

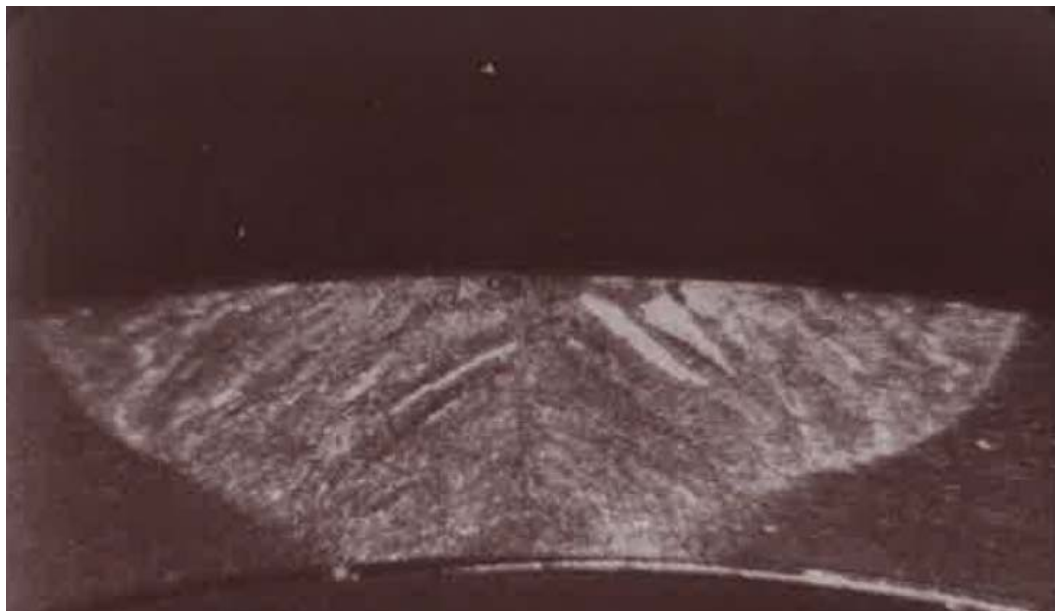
Fig 4. A metallurgical mount of the weld cross-section showed that the 1.00" elbow was manufactured by a TIG (GTAW) welding process. TIG welding is the most commonly used method of welding in tube manufacturing, but it is an older less robust process than is laser welding, resulting in a wider weld bead and larger heat affected zone. This weld bead shape is common in TIG welded tubes.

Fig. 6. A metallurgical mount of the weld cross-section of a sample of straight length 1.50" OD tube was manufactured by a TIG (GTAW) welding process. Note that this weld shape is significantly different than that in Fig. 4, which was produced by the same tube manufacturer. This weld bead shape is less common in TIG welded tubes than that shown in Fig. 4.

Fig 7. A metallurgical mount of the weld cross-section of a sample of straight length 0.50" OD tube was manufactured by a TIG (GTAW) welding process. Note that this weld shape is significantly different than in previous photos. It is less common in TIG welded tubes than that shown in Fig. 4. All samples are from the same tube manufacturer.

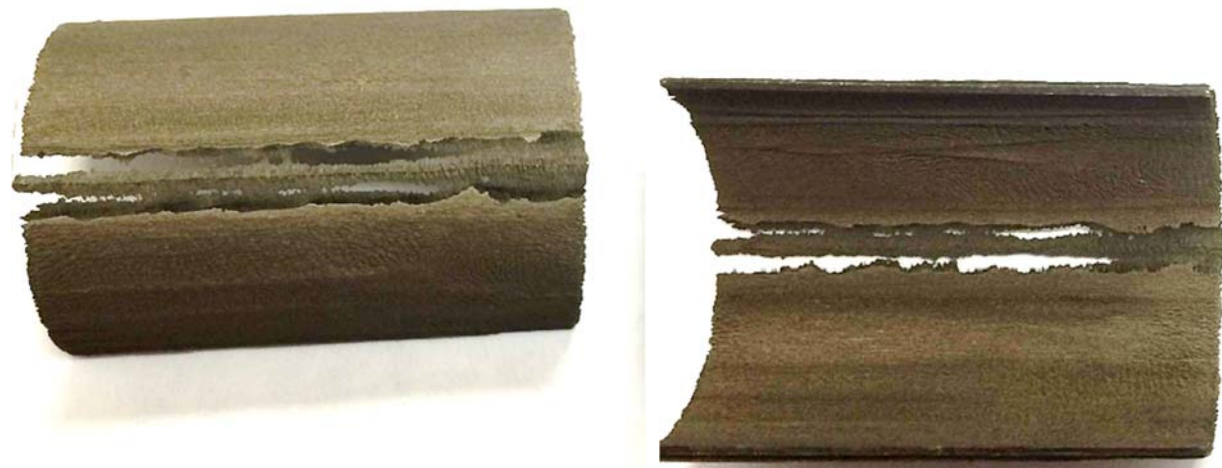
Fig.8. Results of ASTM A249/S7 weld decay corrosion test of the 1.00" elbow. Most of the longitudinal weld in this sample was consumed during the test. The OD surface is shown at left and the ID surface is shown at right.

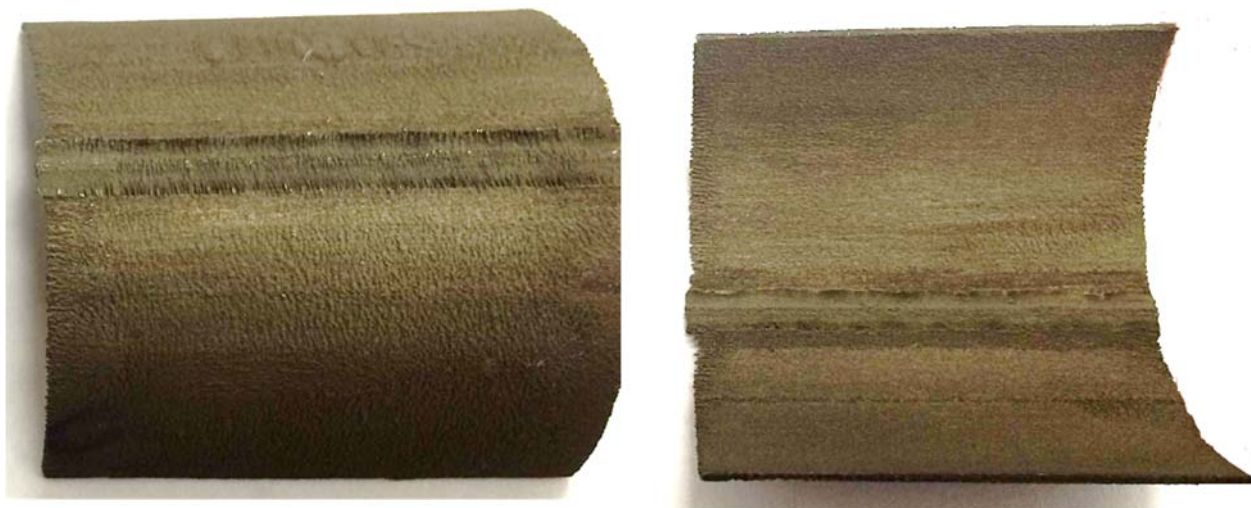
Fig. 9. Results of ASTM A249/S7 weld decay corrosion test of one leg of the 1.50" Tee. The longitudinal seam weld of the tube in this sample did not exhibit the same level of attack as in the elbow, but there was evidence of accelerated thinning along the weld fusion line / heat affected zone. This level of ditching along the edges of the weld indicates failure of the sample. Through-wall holes were noted in the weld heat affected zone, also constituting failure. The OD surface is shown at left and the ID surface is shown at right.

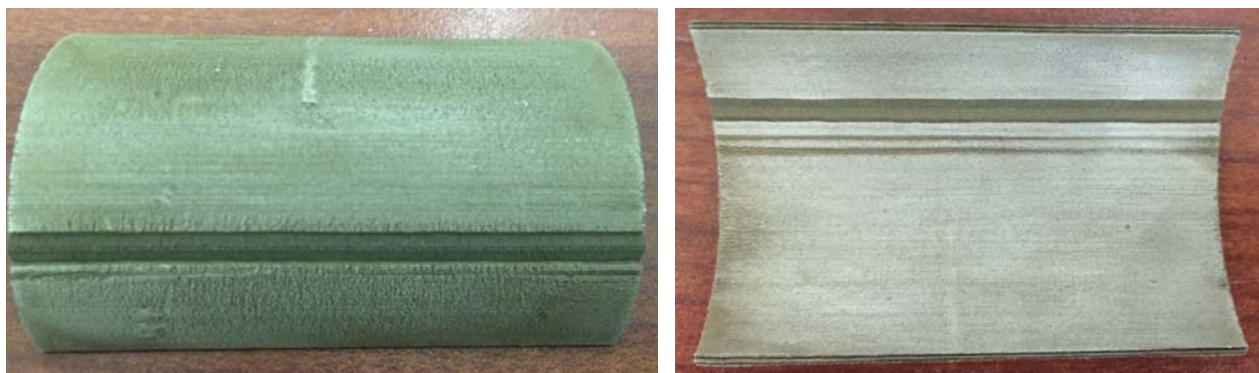
Fig. 10. Results of ASTM A249/S7 weld decay corrosion test of the 1.50" straight tube sample. The longitudinal seam weld of the tube in this sample did not exhibit the same level of attack as in the elbow, but there was evidence of accelerated thinning along the weld fusion line / heat affected zone. This level of ditching along the edges of the weld indicates failure of the sample. The base metal in this sample was reduced from 0.060" to 0.040" and the weld was reduced from 0.060" to 0.018" when the test was suspended. The resulting corrosion ratio was 2.13, well above the 1.25 maximum allowable. The OD surface is shown at left and the ID surface is shown at right.

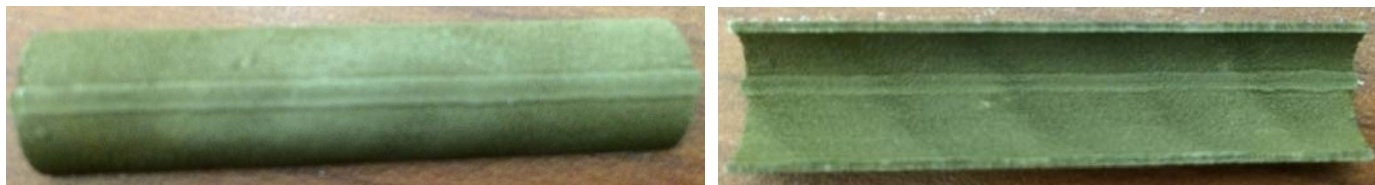
Fig. 11. Results of ASTM A249/S7 weld decay corrosion test of the 0.50" straight tube sample. The longitudinal seam weld of the tube in this sample did not exhibit the same level of attack as in the other samples. The base metal in this sample was reduced from 0.063" to 0.024" and the weld was reduced from 0.061" to 0.032" when the test was suspended. The resulting corrosion ratio was 0.74, an acceptable result. The OD surface is shown at left and the ID surface is shown at right.

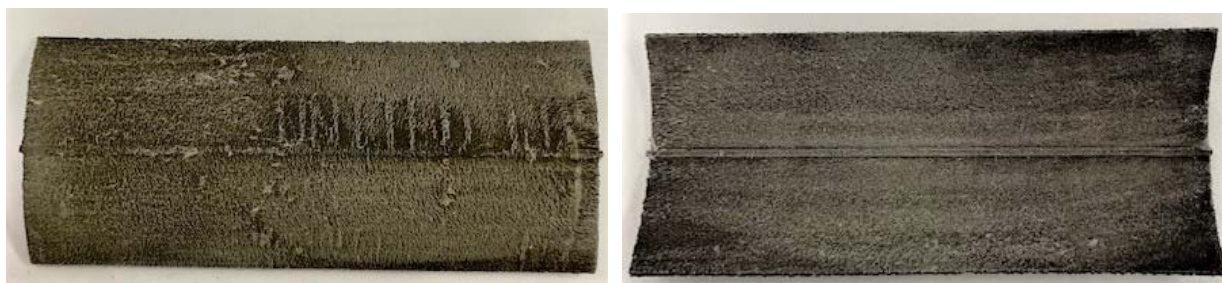
Fig. 12. Results of ASTM A249/S7 weld decay corrosion test of properly processed laser welded 2.50" X 0.065" 316L tubing, heat number A55P. The OD surface is at left and the ID at right. Note that the weld protrudes above the base metal on both surfaces indicating that the weld was more corrosion resistant than the base metal.

The following photos represent good laser welded and properly heat treated tubing after ASTM A249/S7 weld decay testing. Note that the weld metal was more resistant to attack than the base material as evidenced by the respective material thicknesses. Note that there is no localized ditching of the weld fusion line or the heat affected zone. This indicates that there is little to no alloy segregation in the weld metal as a result of the smaller volume of melted metal and the resulting shorter diffusion distances. The distribution of elements in the weld is as homogeneous as that in the base metal. A competitive sample is also shown. This sample was presented in the manufacturer's sales literature as being good welded tubing. The localized ditching along the fusion line of the weld suggests that the weld would be subject to localized attack by chloride bearing solutions of low pH.

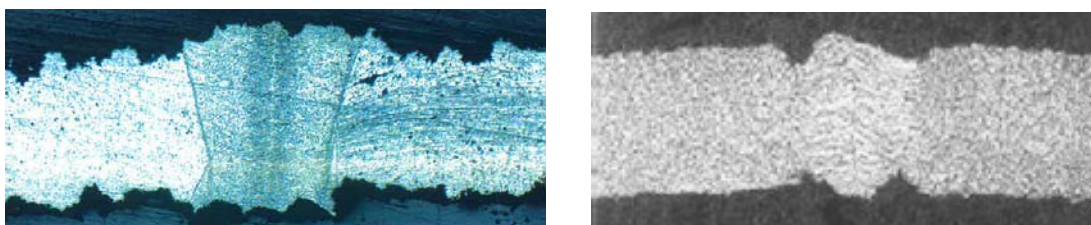
Fig. 13. On the left is a photomicrograph of the above sample showing a transverse section. Note the uniform attack across the base metal and weld on both the ID and OD surfaces. The corrosion ratio was 0.68.

On the right is a competitive laser welded tube section showing localized ditching of the fusion line and heat affected zone. The corrosion ratio of this sample was 1.25.
